AL-V-A-280

Fairview Farm Midlothian Private

circa 1900

INVENTORY FORM FOR STATE HISTORIC SITES SURVEY

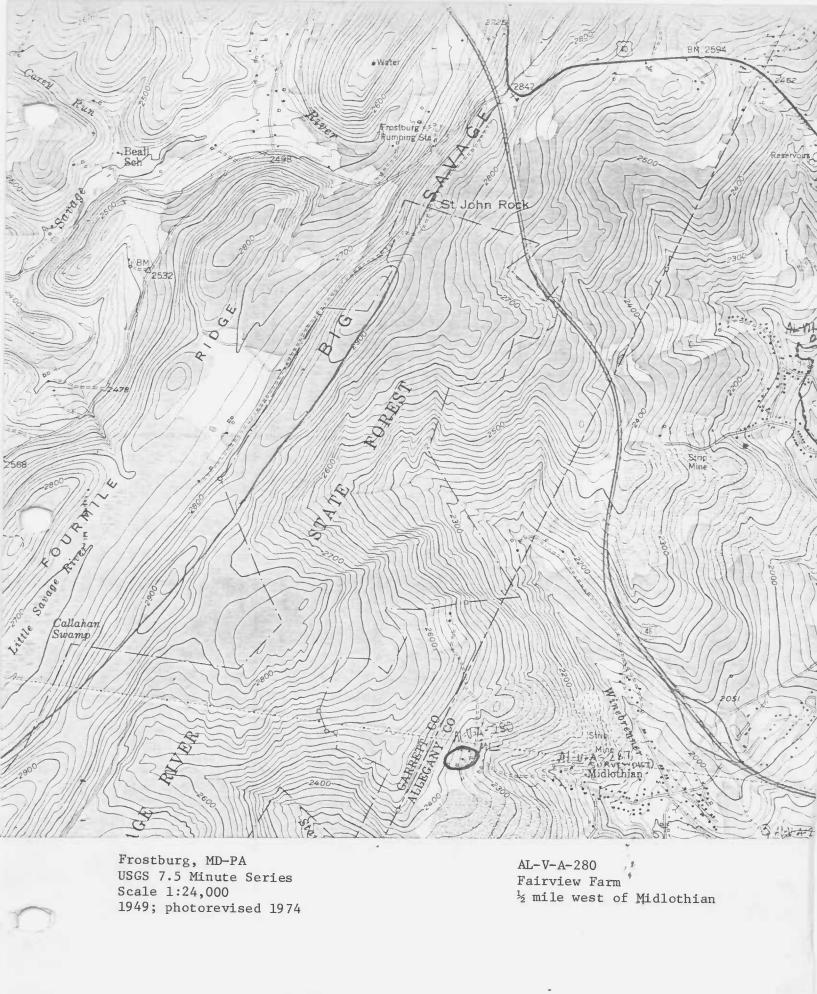
AL-V-A-280 Fairview Farm Allegany Co., MD David A. Dorsey 6/81 Willaim Barnes Hs. E elev.

The earlier of the dwellings is the William Barnes House. The two and one-half story building is three bays wide on the facade (eastern elevation), and two bays deep. Wall construction of the house is frame with vinyl siding covering the original wooden siding. It rests on a high random rubble stone foundation. The gable roof is covered with asphalt shingles. A wrap or round veranda on the facade and the northern and southern elevations has a hipped roof supported by square wooden posts. Windows are 1/1 sash. An entrance is in the center of the facade. An exterior brick chimney is on the southern elevation.

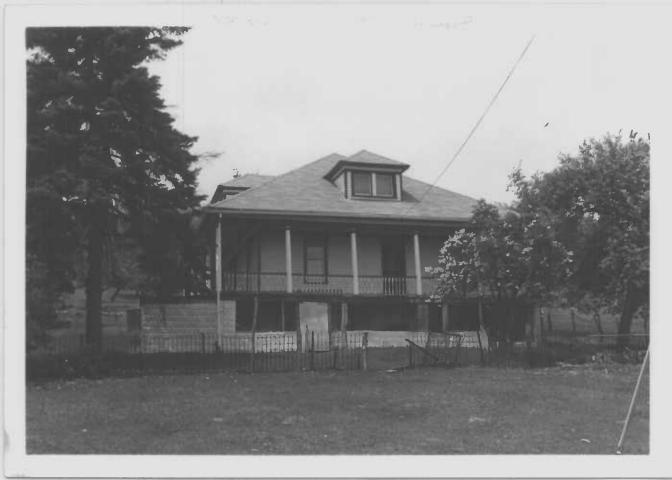
AL-V-A-280
Fairview Farm
Allegany Co., MD
David A. Dorsey 6/81
Henry Barnes Hs. E elev.

The other dwelling is the Henry Barnes House. This one and one-half story dwelling is three bays wide on the facade (eastern elevation), and three bays deep. Wall construction is frame covered with weatherboard siding. The building rests on a high rubble stone foundation. The pyramidal roof is covered with asphalt shingles. Eaves consist of a boxed cornice, soffit, bed mould, and a wide frieze. An umbrage porch on the facade and southern elevation has turned balusters and wooden Kaman Doric columns. Windows are 1/1 sash. An entrance in the center of the facade includes a mine light frame and glass door which is surmounted by a transom. A brick chimney is located on the interior of the house. Hipped dormers, each with a pair of single pane windows, are located on the facade and southern elevation.

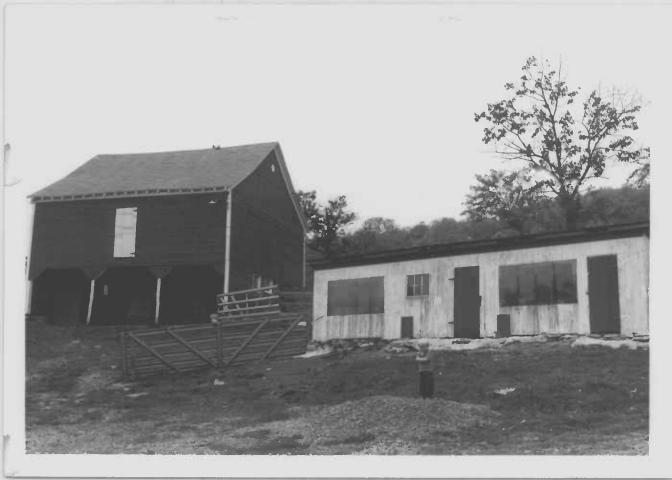
AL-V-A-280
Fairview Farm
Allegany Co., MD
David A. Dorsey 6/81
Barn & Coop, View to SE

Two barns are located to the south of the William Barnes House. A bank barn is of frame construction and is covered with german siding, weatherboards, and beaded flushboards. It rests in a high rubble stone foundation. A forebay on the eastern elevation of the barn is supported by wooden posts. The gabled roof of the barn is covered with corrugated metal. The second barn, also of frame construction, is covered with german siding. The gabled roof is covered with slate shingles.

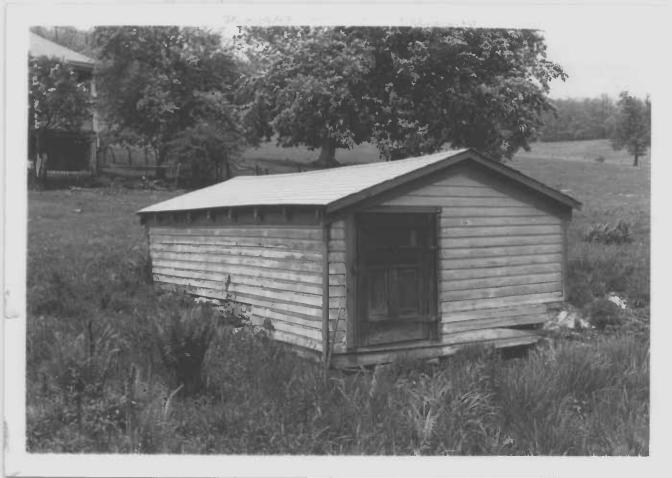
AL-V-A-280
Fairview Farm
Allegany Co., MD
David A. Dorsey 6/81
Springhs. E elev.

Outbuildings include two vertical board chicken coops, a hutch, sheds, a small board and batten structure, a garage, and a springhouse. The frame springhouse is covered with weatherboards. It rests on a low rubble stone foundation. The gabled roof is covered with asphalt shingles. An entrance is on the eastern elevation of the springhouse.

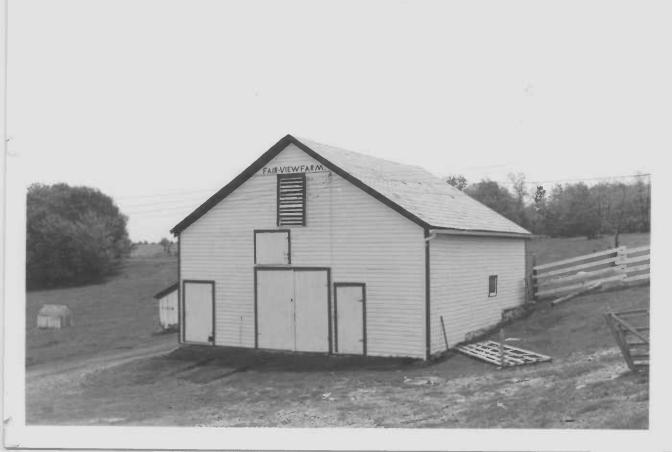
AL-V-A-280 Fairview Farm Allegany Co., MD David A. Dorsey 6/81 Barn N elev.

The barn rests on a low rubble stone foundation. Four vertical board doors on the northern elevation, including a loft door, open on hinges. A louvered ventilator is located in the peak of the gable.
